State of Nevada  
Department of Conservation & Natural Resources  
Division of State Parks  
Valley of Fire State Park  
Facility Condition Analysis

**Site Number: 9963**  
**STATE OF NEVADA PUBLIC WORKS DIVISION**  
**FACILITY CONDITION ANALYSIS**

Report Printed in April 2013

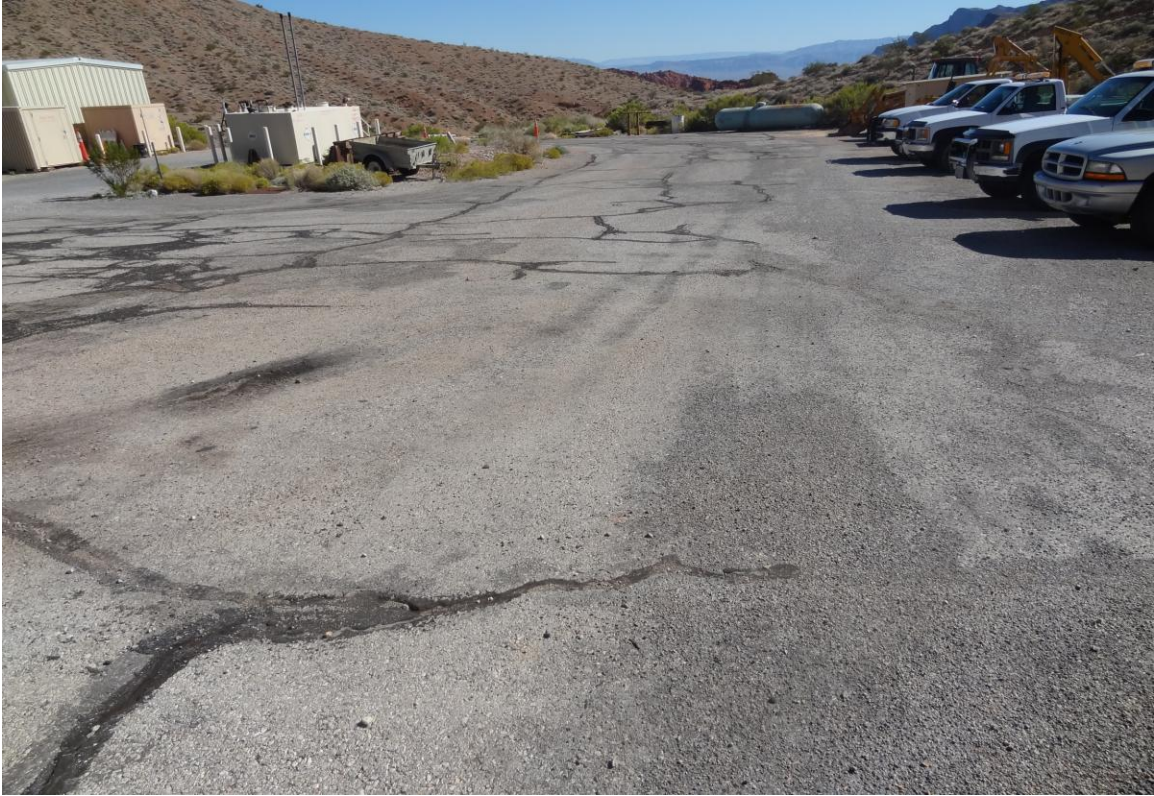
The asphalt paving in the maintenance yard area is failing, with significant alligatoring, settling and cracks observed. This project covers the removal and replacement of the existing asphalt in the maintenance yard up to the access road that NDOT maintains. Striping for safety, parking and loading zones is included in this estimate. 24,000 square feet was used to generate this estimate.

Valley of Fire State Park – FCA Site #9963  
Description: Maintenance area pavement in need of repair.

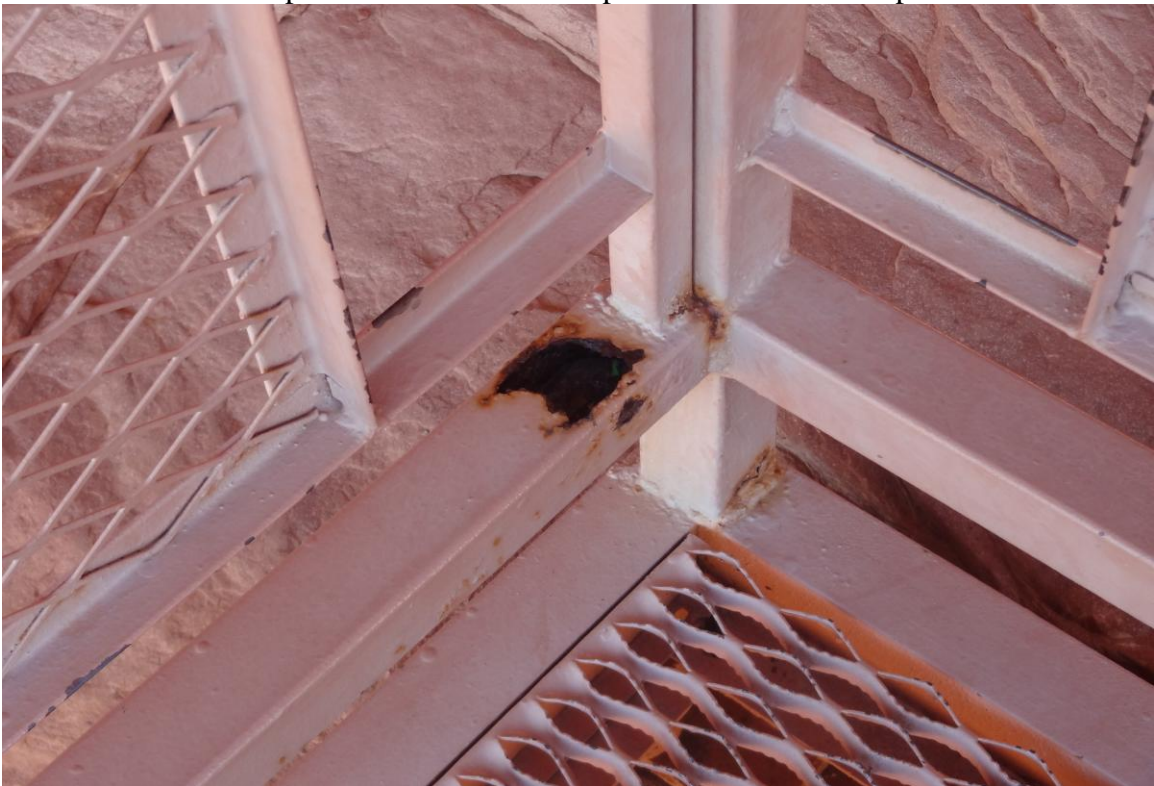
Valley of Fire State Park – FCA Site #9963  
Description: Stairs / landings in need of repair at Atlatl Rock.

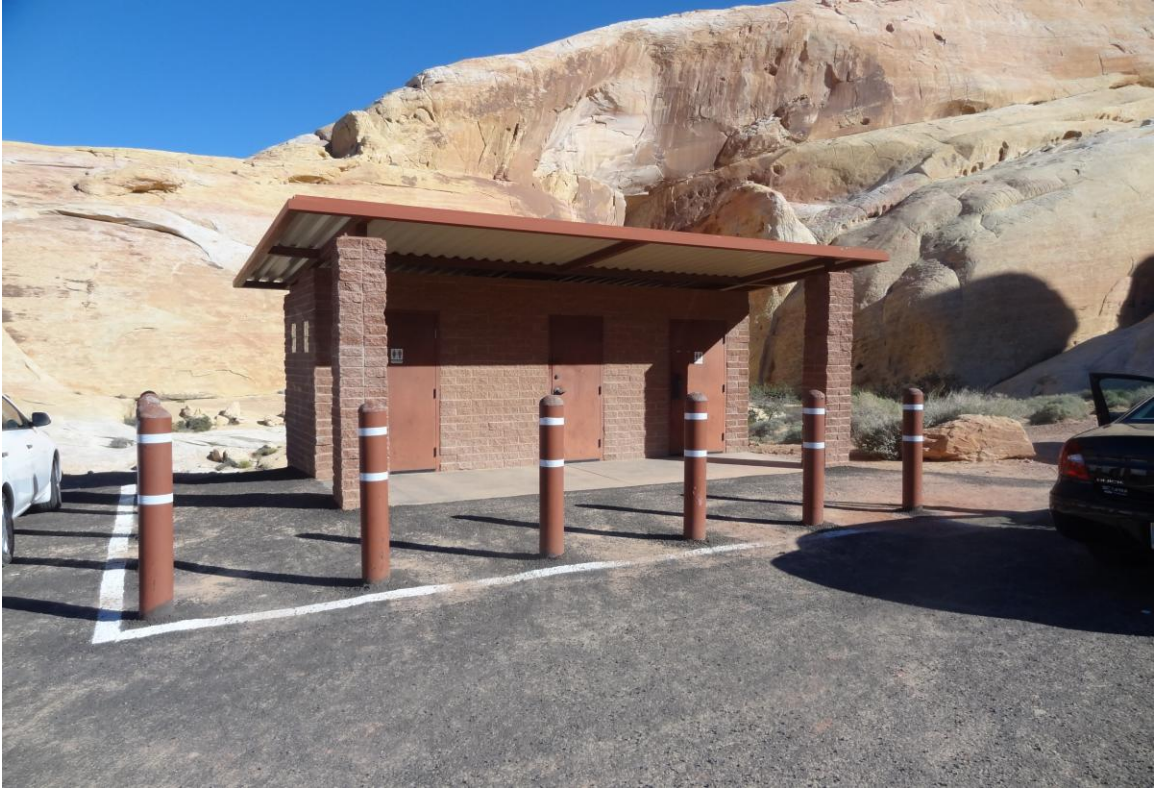
White Dome Comfort Station – FCA Building #3154  
Description: Exterior of the building.

The Comfort Station is a concrete masonry unit and steel framed structure with a metal roofing system on a concrete foundation. It has Men's and Women's restrooms and is the only CLIVUS style composting restrooms in the park. The building is not ADA compliant.

It is important to maintain the finish, weather resistance and appearance of the building. This project would provide funding to protect the exterior of the building excluding the roof. Included in the cost are cleaning and sealing the brick masonry and caulking of the windows, flashing, fixtures and all other penetrations. It is recommended that the building be sealed and caulked in the next 2-3 years and that this project be scheduled on a cyclical basis to maintain the integrity of the structure.

The interior finishes are in fair condition. It is recommended that the interior walls and ceilings be painted at least once in the next 2-3 years and that this project be scheduled on a cyclical basis to maintain the integrity of the structure. Prior to painting, all surfaces should be repaired and prepped. An epoxy-based paint should be utilized in wet areas for durability.

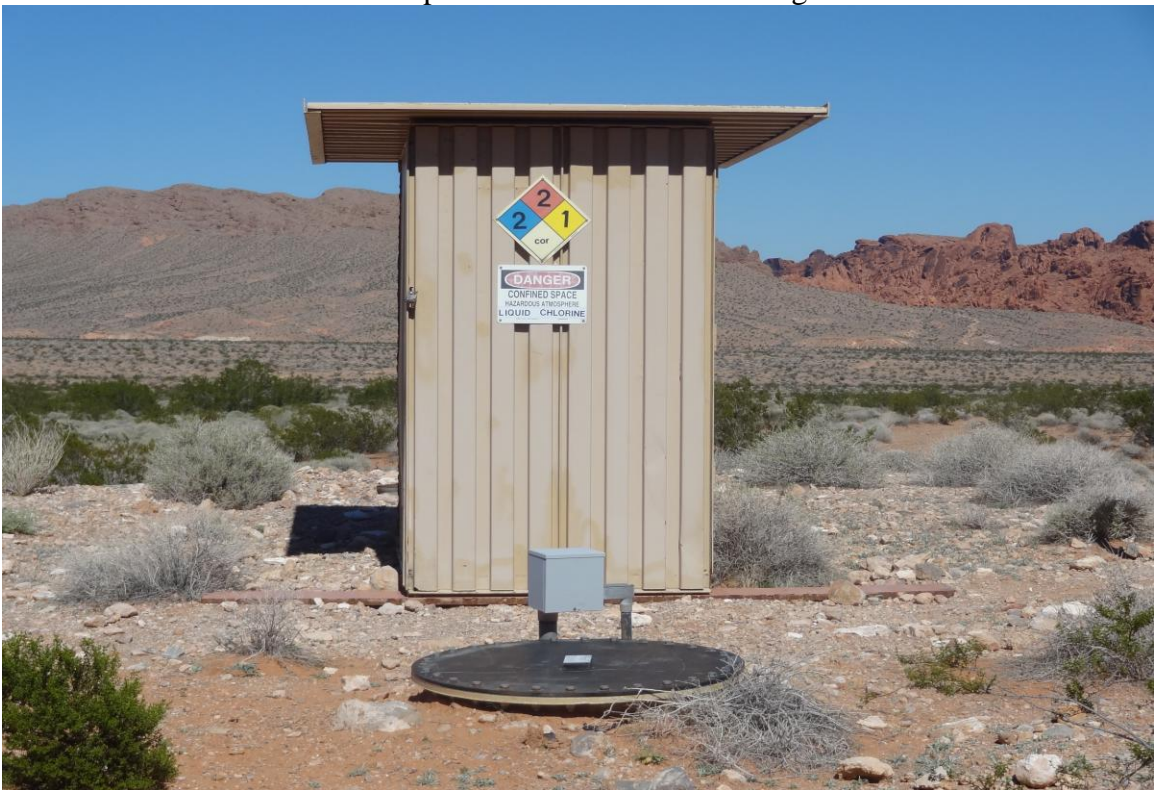
Water Treatment Shed – FCA Building #3153  
Description: Exterior of the building.

The existing automatic chlorine injection system in the building is older and the State Health Department has recommended an upgrade to the system. Poor production from the system causes wear and tear on the domestic water supply lines, plumbing fixtures and HVAC equipment. This project would provide for the replacement of the existing system with new equipment. This project would also provide for a chemical treatment program including an updated chemicals control system, service and employee training provided by a qualified water treatment vendor. The annual maintenance fee charged by the water treatment vendor would be determined after an investigation of the water system is complete. These annual costs are not included in this project cost. For budgeting purposes, a \$12,000 fee is suggested.

It is important to maintain the finish, weather resistance and appearance of the building. This project would provide funding to protect the exterior of the building excluding the roof. Included in the cost is the caulking and sealing of the flashing, fixtures and all other penetrations. It is recommended that the building be caulked and sealed in the next 2-3 years and that this project be scheduled on a cyclical basis to maintain the integrity of the structure.

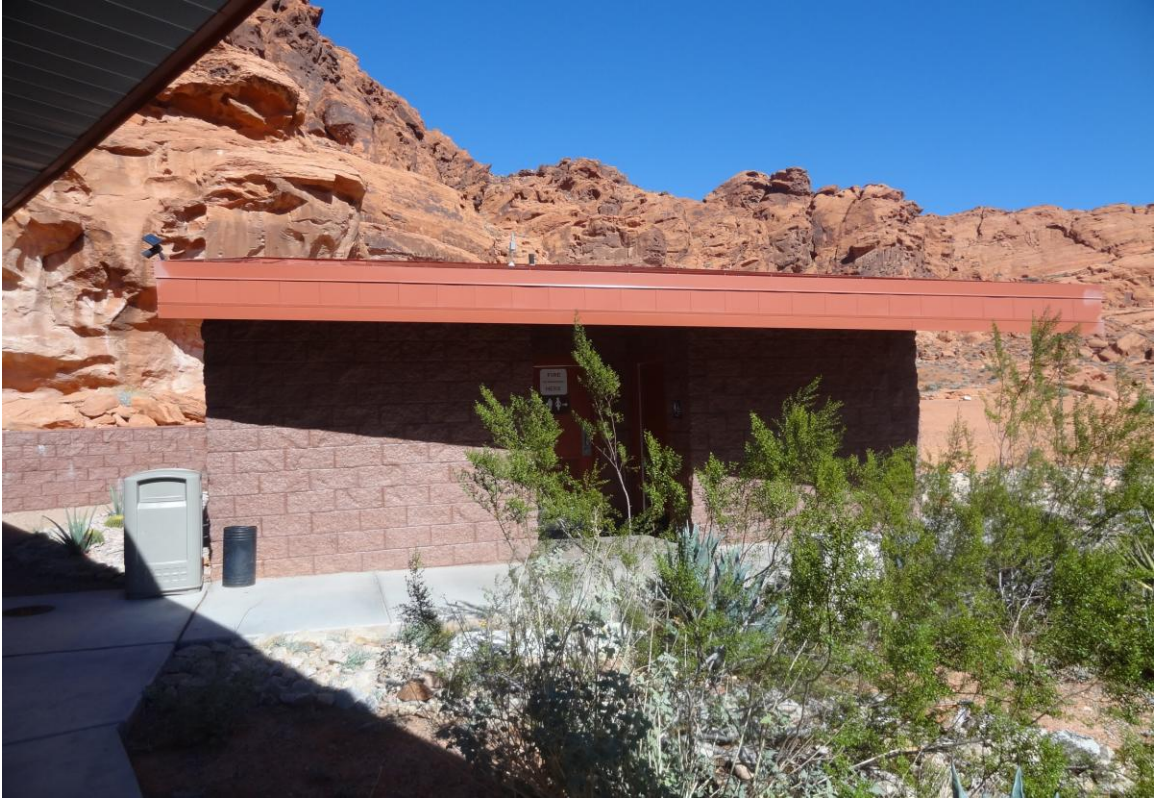
Visitors Center Comfort Station – FCA Building #3152  
Description: Exterior of the building.

The Comfort Station is a concrete masonry unit and steel framed structure with a single-ply roofing system on a concrete foundation. It has Men's and Women's ADA compliant restroom facilities and is located adjacent to the Visitor's Center.

It is important to maintain the finish, weather resistance and appearance of the building. This project would provide funding to protect the exterior of the building excluding the roof. Included in the cost are cleaning and sealing the concrete masonry units, painting the metal trim and caulking of the windows, flashing, fixtures and all other penetrations. It is recommended that the building be sealed and caulked in the next 4-5 years and that this project be scheduled on a cyclical basis to maintain the integrity of the structure.

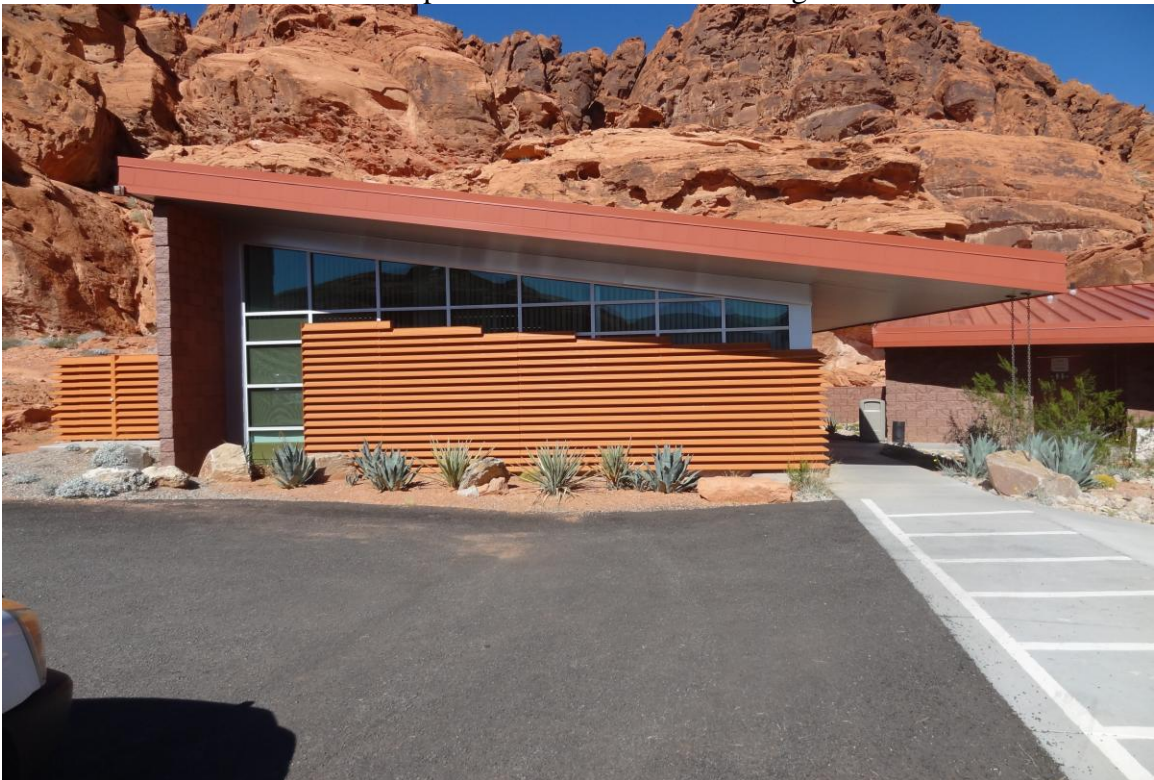
Valley of Fire Administration Building – FCA Building #3151  
Description: Exterior of the building.

The Administration Building is a concrete masonry unit and steel framed structure with a single-ply roofing system on a concrete foundation. It contains office spaces, storage and a conference room for park personnel. The building has a split HVAC system and has a fire alarm and sprinkler system.

It is important to maintain the finish, weather resistance and appearance of the building. This project would provide funding to protect the exterior of the building excluding the roof. Included in the cost are cleaning and sealing the concrete masonry units, painting the metal trim and caulking of the windows, flashing, fixtures and all other penetrations. It is recommended that the building be sealed and caulked in the next 4-5 years and that this project be scheduled on a cyclical basis to maintain the integrity of the structure.

The interior finishes are in fair condition. It is recommended that the interior walls and ceilings be painted at least once in the next 4-5 years and that this project be scheduled on a cyclical basis to maintain the integrity of the structure. Prior to painting, all surfaces should be repaired and prepped. An epoxy-based paint should be utilized in wet areas for durability.

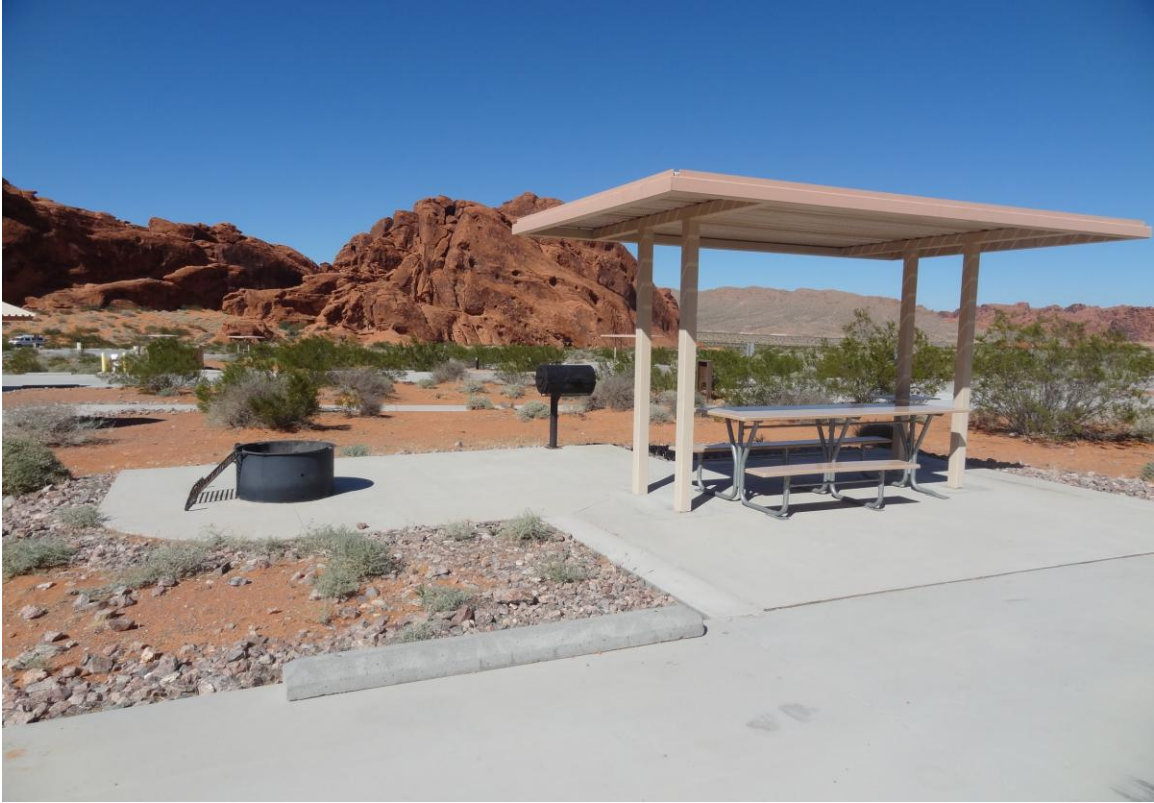
Typical Shade Ramada – FCA Building #2892  
Description: Exterior of the structure.

There are 80 steel shade ramadas and 4 steel carports in different locations throughout the site which add up to a total of 28,890 square feet. It is important to maintain the finish, weather resistance and appearance of the structures. This project would provide for painting of the structures and it is recommended that this project be scheduled on a cyclical basis to maintain the integrity of the structures.
